FRESH AIR/RECIRCULATION SERVO MOUNT REPAIRING GROUP 87, NO. 90-01

1990 Audi 200

TECHNICAL SERVICE BULLETIN

Model(s): 1984-88 Audi 5000
1989-on Audi 100, 200
Group: 87 - Air Conditioner
Bulletin No.: 90-01
Date: November, 1990

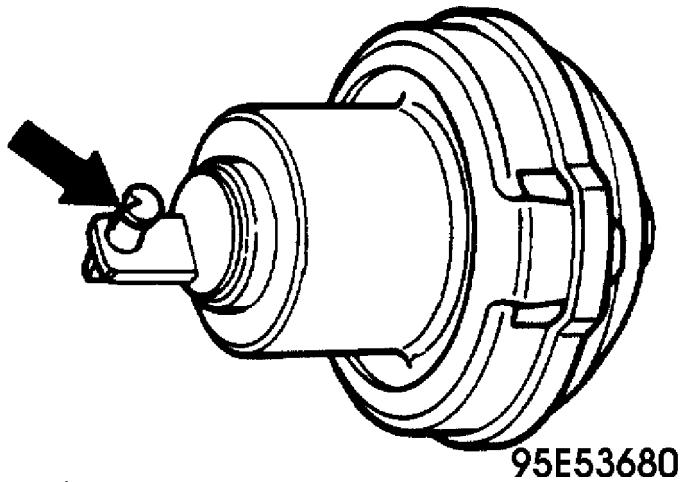
Fig. 6: Location Of Cracks In Servo End

- Inspect end of fresh air/recirculation servo for cracks, replace servo if damaged. See Fig. 6, (arrow).
- Check servo diaphragm for leaks using hand vacuum pump US 8026.
