UPDATING AUTOMATIC CLIMATE CONTROL SYSTEM - INFO GROUP 87, NO. 86-01

1984 Audi 5000S

UPDATING AUTOMATIC CLIMATE CONTROL SYSTEM

Model(s): 1984-on Audi 5000
Group: 87
Bulletin No.: 86-01
Date: July 22, 1986

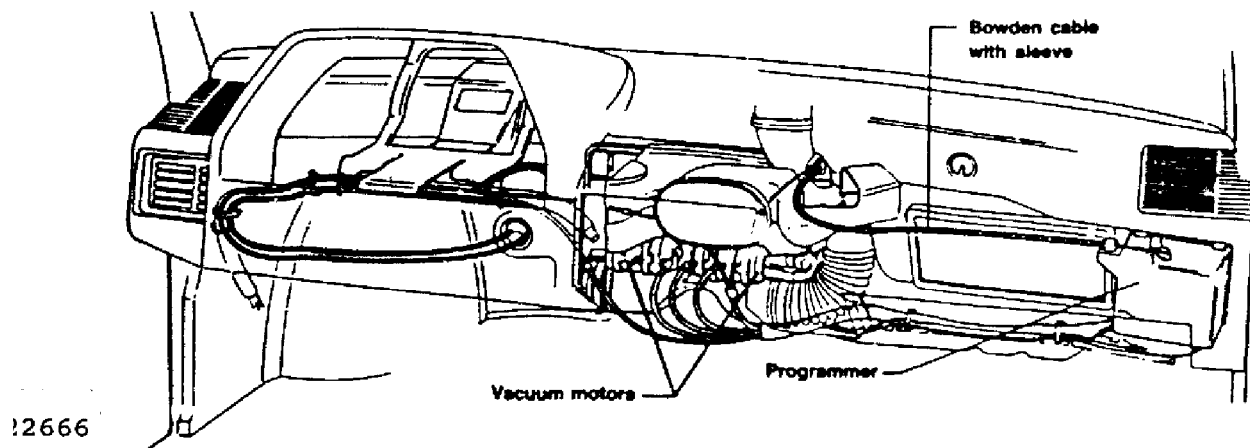
Fig. 1: Bowden Cable Routing

- Check Bowden cable for correct positioning. See Fig. 1.
- Open glove box door.
- Set climate control temperature from maximum cold 60 degrees F (15 degrees C) to maximum heat 90 degrees F (32 degrees C).
- Check lever on programmer.

* Lever must be in full heat position (all the way to the right) after 2 minutes.

If lever moves slowly or stops before reaching maximum heat position do the following:

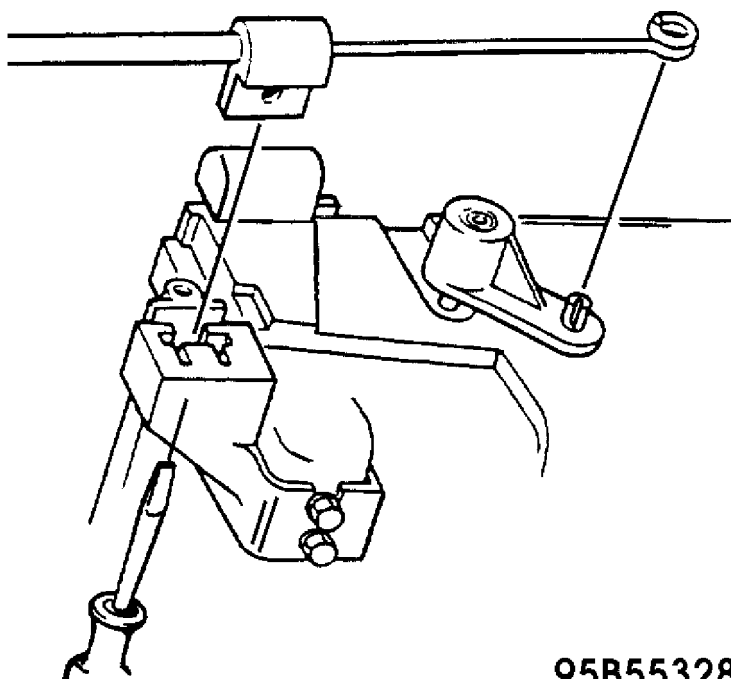
Fig. 2: Removing Bowden Cable From Lever

- Set temperature to 90 degrees F (32 degrees C) and wait until lever stops.
- Remove Bowden cable from lever on programmer. See Fig. 2.
- Attach pull-type spring scale to eye of Bowden cable.
- Pull scale in horizontal direction.
- Record force required to close heater flap.

* Force must be 15N or less.

If force required to close heater flap is greater than 15N

- Remove heater box and replace heater flap.

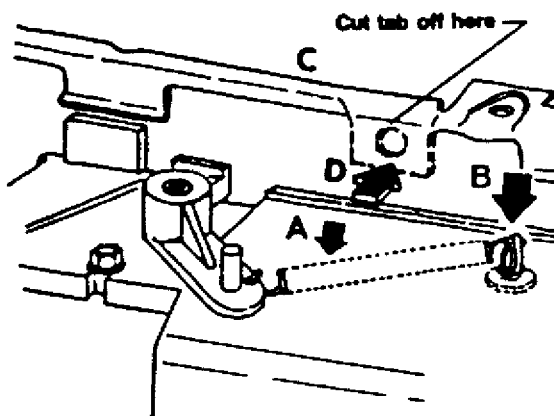
Fig. 5: Location Of Tab "D" On Programmer Bracket "C"

- Check to see if programmer bracket (C) has tab (D). See Fig. 5.

If tap (D) is present,

- Remove bracket from programmer.
- Cut tab (D) off bracket.
- Reinstall bracket on programmer.

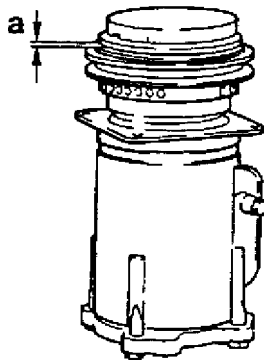
Fig. 11: A/C Compressor Clutch Air Gap

- Measure air gap between A/C compressor clutch and pulley. See Fig. 11.

* $a = 1.5 \text{ mm} + 0.6 \text{ mm}$

If air gap is not within specifications,

- Replace A/C compressor clutch.

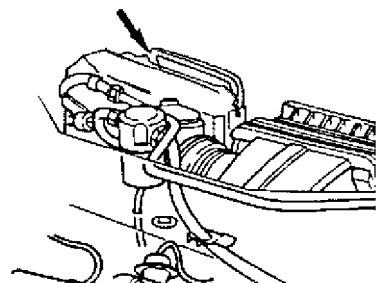
Fig. 13: Open Fresh Air Flap

- Remove water tray from air plenum under hood.
- Set A/C temperature to 90 degrees F (32 degrees C).
 - * Fresh air flap must be open and recirculation air flap closed. See Fig. 13 (arrow).
- Set A/C temperature to 60 degrees F (15 degrees C).
 - * Fresh air flap must be closed and recirculation air flap open. See Fig. 14.

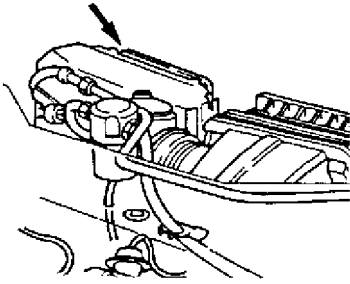
Fig. 14: Closed Fresh Air Flap

If air recirculation flap remains open,

- Check connector piece on vacuum motor.

If broken,

- Replace vacuum motor.

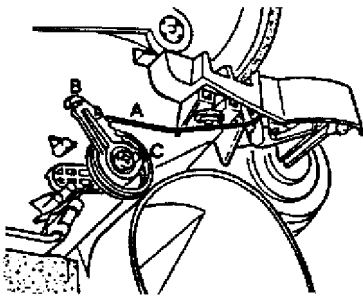
Fig. 15: Pull Rod "A" Location

If there is a whistling noise when using higher fan stages, do the following :

- Remove parcel shelf and footwell vent from driver's side.
- Remove air duct form heater housing.
- Set A/C temperature to 68 degrees F (20 degrees C) or 90 degrees F (32 degrees C).
- Press DEFROST button.
- Check to see if a clamp is mounted on heater flap lever (B). See Fig. 15.

If no,

- Install new heater flap lever Part No. 443 819 291 E.

- Remove pull rod (A). See Fig. 15.
- Remove screw and washer.

- Remove heater flap lever with return spring.
- Install new heater flap arm.
- Install return spring (C). See Fig. 15.
- Install washer, screw and pull rod.
- Install air duct, footwell vent and parcel shelf.

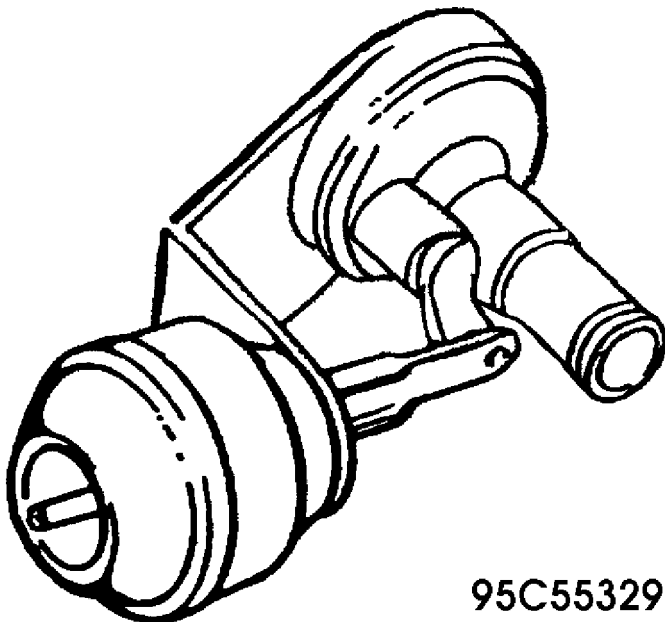
Fig. 16: Heater Valve

- Check heater valve for leaks.
- Replace if necessary.

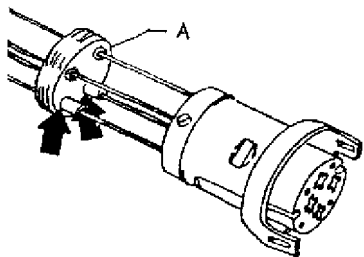
Fig. 18: Connector Housing Sealing Gasket & Rubber Tubes

10 NO HEAT SETTING UP TO AND INCLUDING 84°F (23°C)

- Remove water tray from air plenum in engine compartment.
- Remove yellow 4 point connector from evaporator.
- Remove both sealing gaskets (A) from connector housing with small screwdriver. See Fig. 18.
- Cut off rubber tubes (arrows) of sealing gasket. See Fig. 18.

- Push sealing gaskets into connector housing.
- Reconnect connector.
- Install water tray over air plenum.
- Test climate control regulation at settings from 60°F (15°C) to 84°F
